**A Historical and Architectural Study of
Three Rustic Structures at Giant Forest in Sequoia National Park
The Market, District Ranger's Residence, and Comfort Station**

Prepared by
C. Craig Frazier and Craig A. Kenkel
Historical Architects

**HISTORIC STRUCTURES REPORT
SEQUOIA NATIONAL PARK**

Approved
December 7, 1988

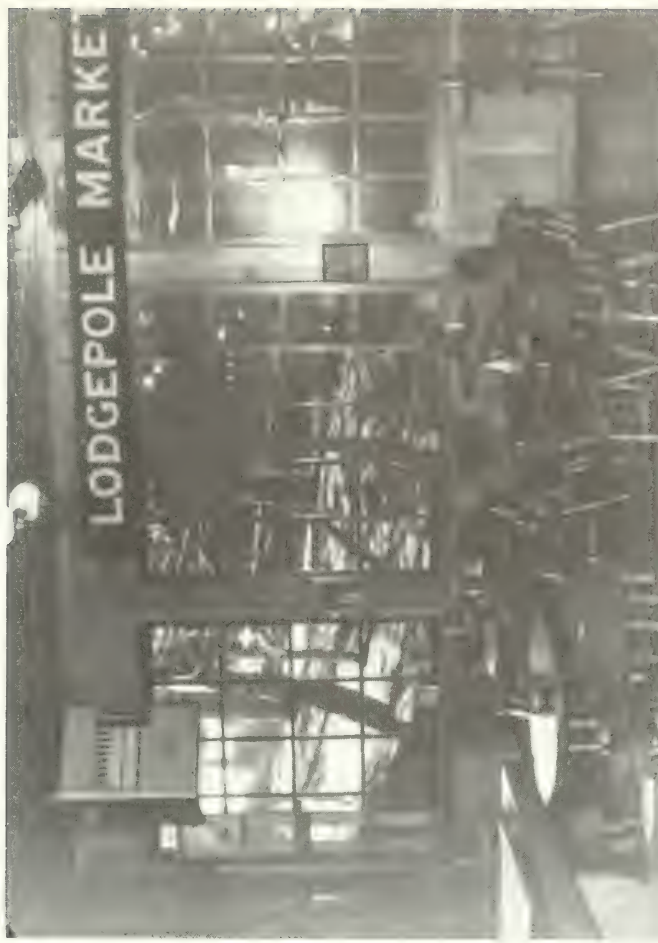
Figure 61 (right). Market, Lounge Interior (room 100) (5/86). The dark strip flooring, knotty pine paneling and an electrified gas lamp are visible in this view looking south towards the large multi-paned picture windows. The sequoia wood bar top and stone fireplace are at left. Notice intrusive character of ceiling hung heating unit. The absence of fluorescent lighting helps preserve this room's historic character.

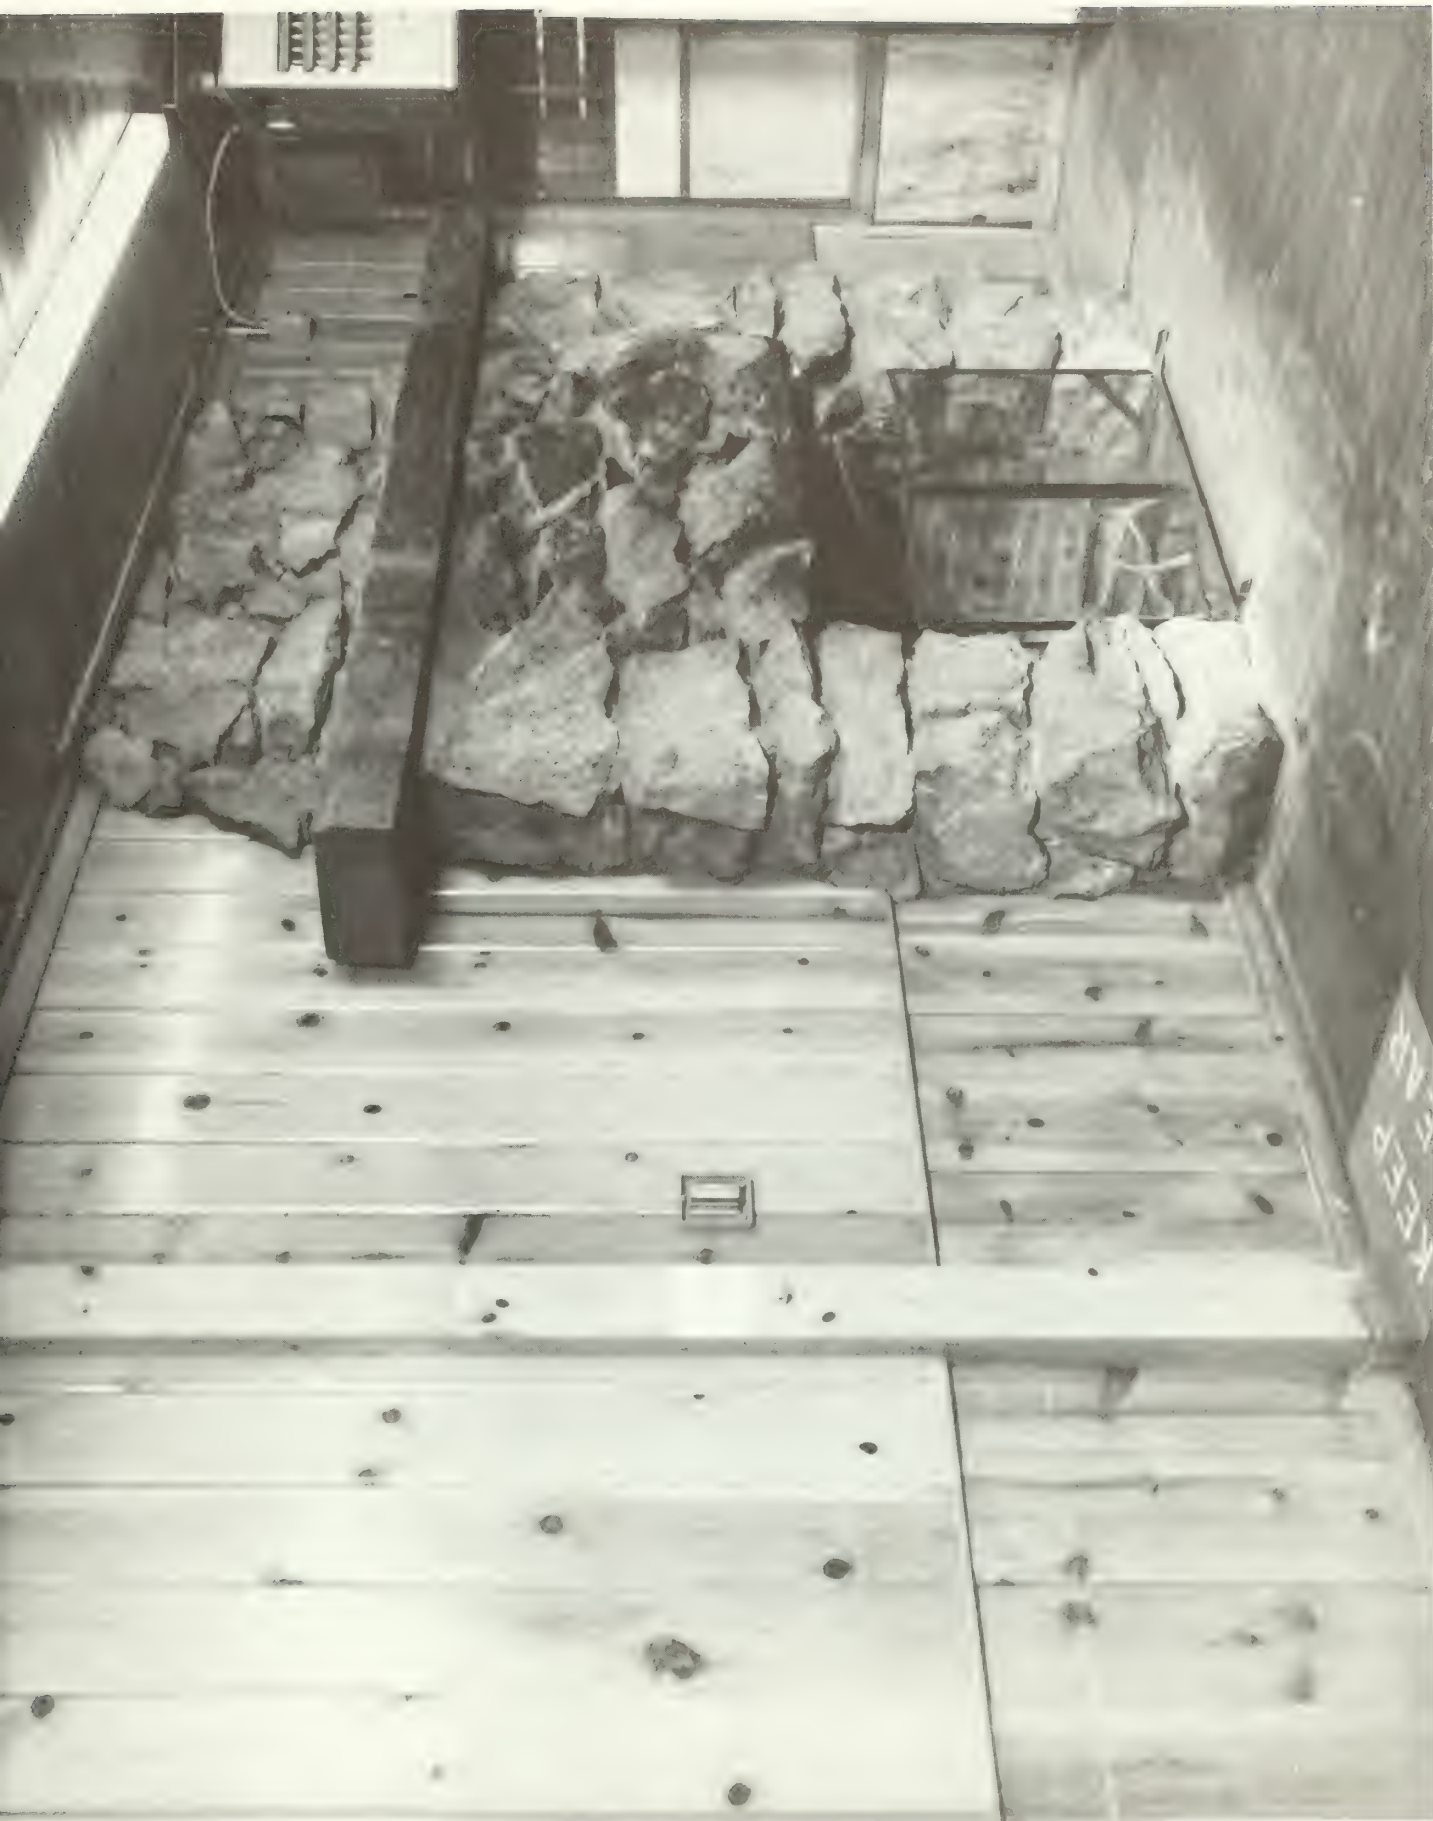
Figure 62. Market Fireplace (ca. 1983). This photograph pre-dates the 1983 remodeling of the Fireside Lounge (room 100)--the bar has yet to be installed here. A clear view is provided of knotty pine paneling, wainscot and the large stone fireplace. Also of note, is the southeast corner where plywood patches are present at the wainscot and floor due to material decay (see Appendix A for investigation findings in this corner). Notice, too, that 1975 fluorescent fixtures are still present and have not been replaced by the current electrified gas lamps (see figure 61). (HABS #CA 2148 B-7).

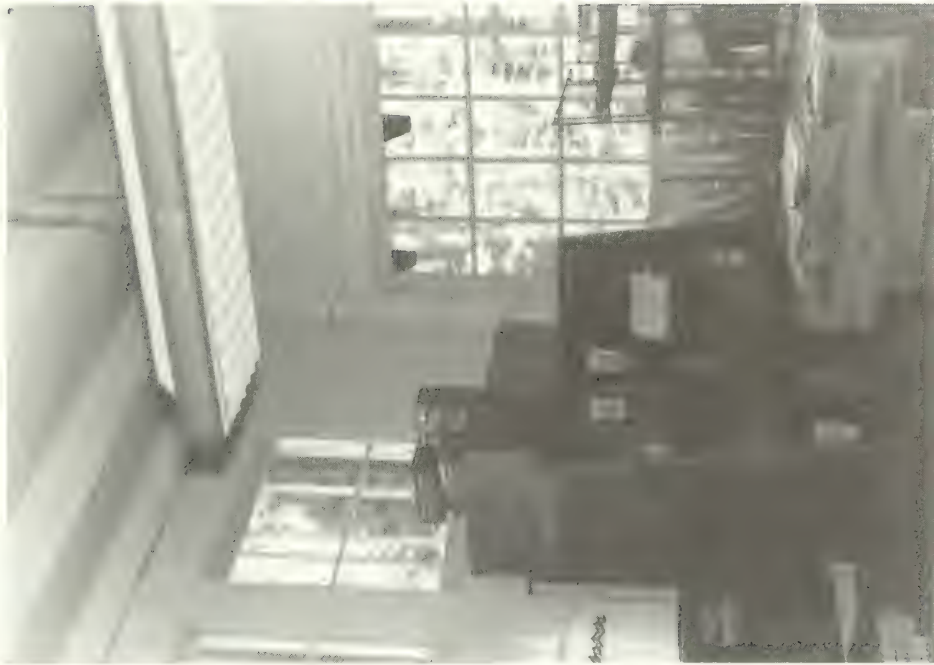
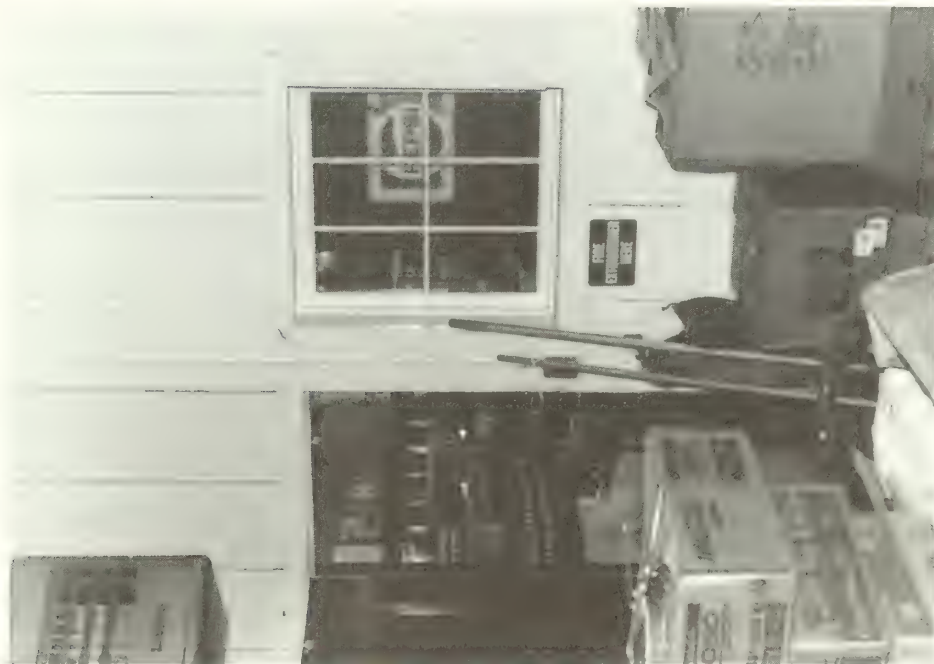
Figure 63. Market Room 102 (5/86). These views show the light and airy quality of room 102 with its array of windows and verticle paneling (3/8" x 11-3/4") painted white. The left view shows the doorway and window communicating with room 101 (the store). In the right view, the ceiling joists are exposed; fiberboard panels define the ceiling. Knotty pine was never installed on the ceilings in this room. Notice intrusive character of fluorescent light fixture.

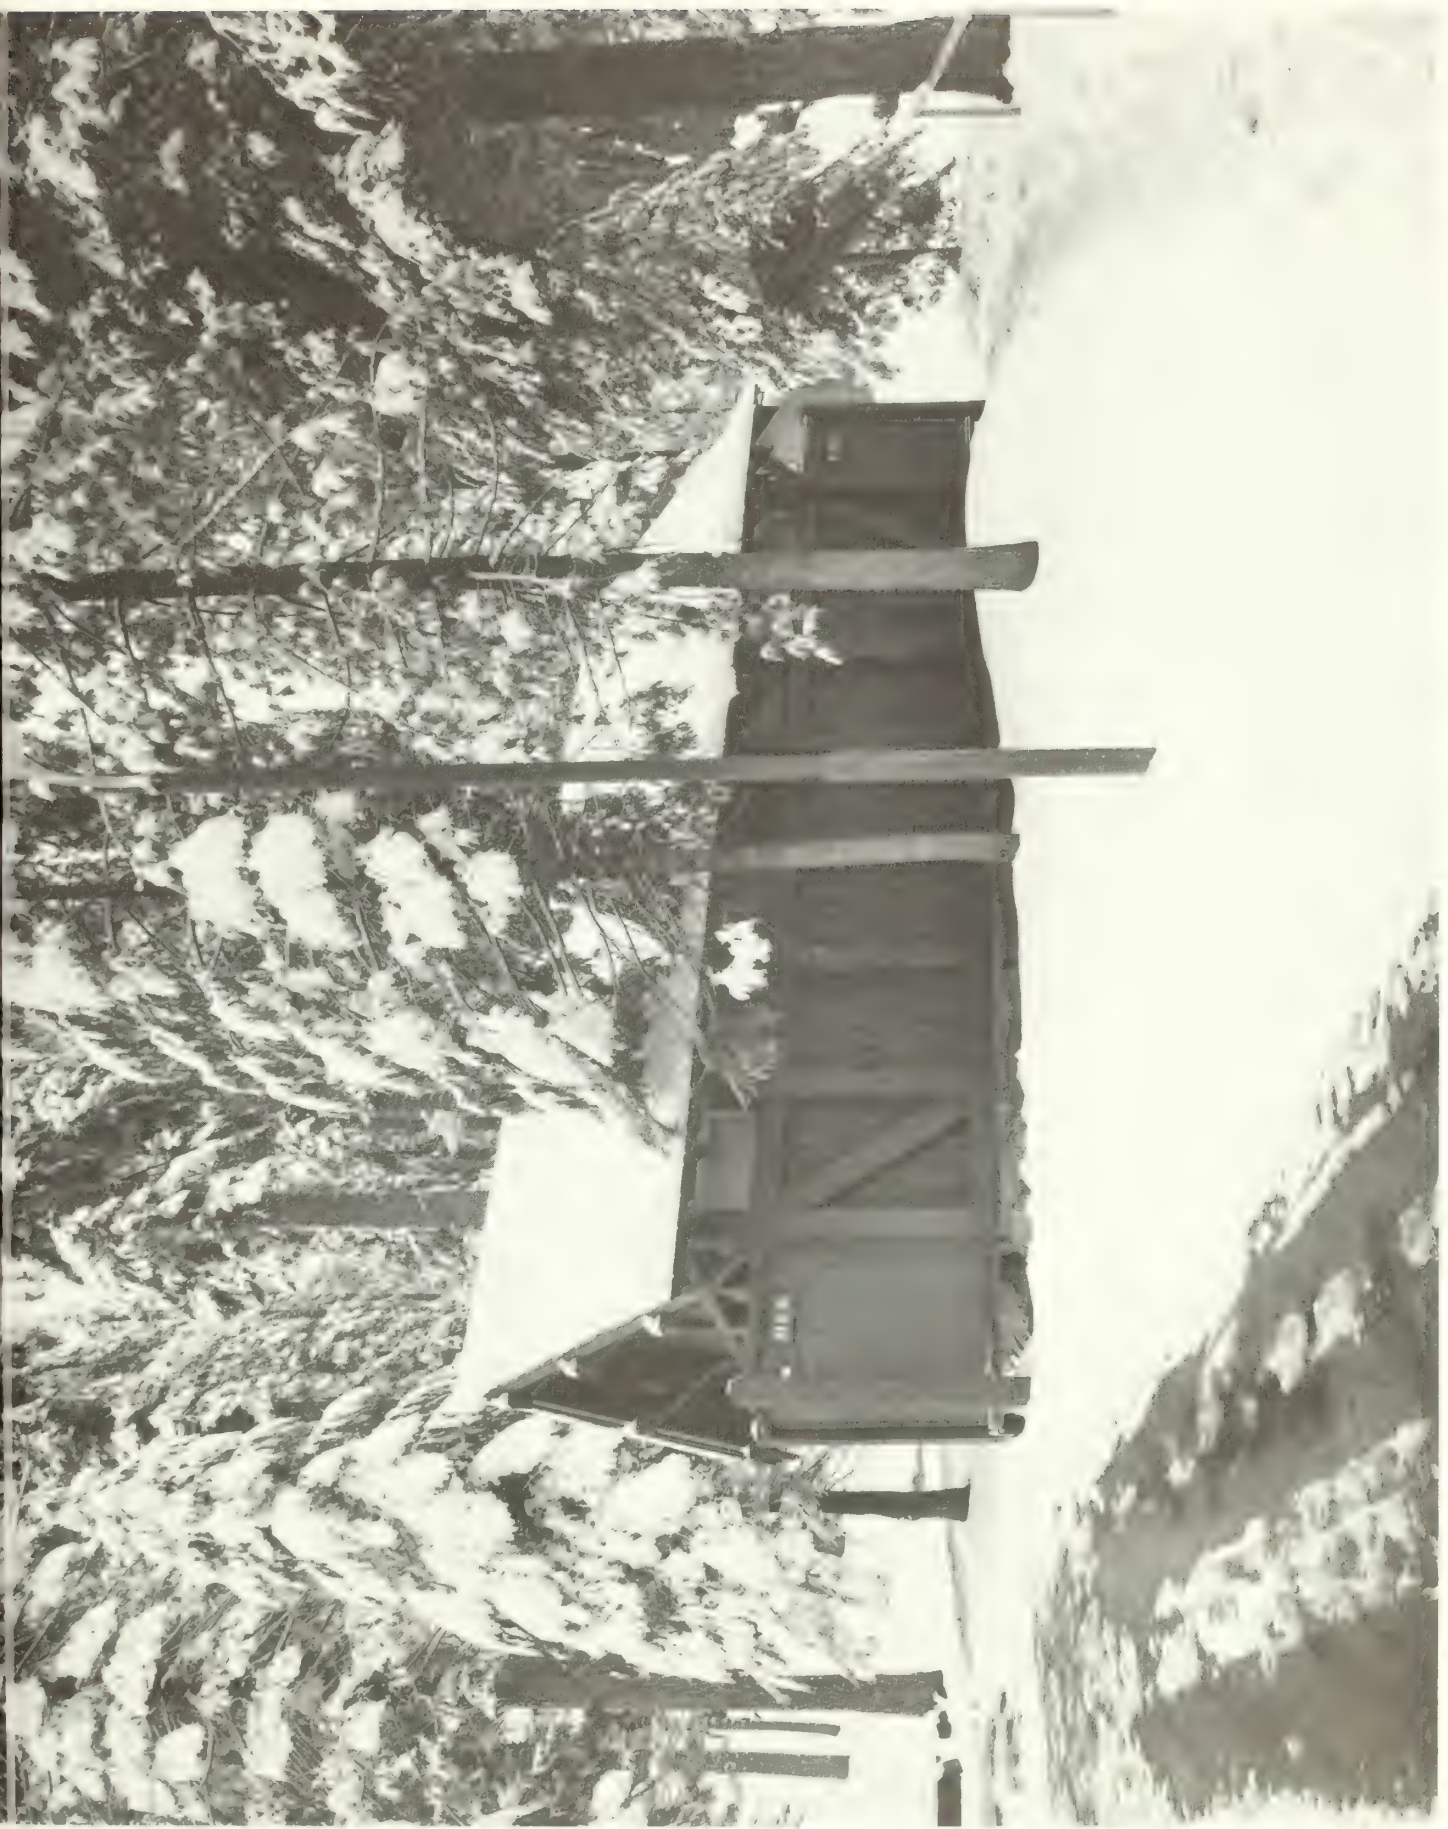
Figure 65. Comfort Station, View from West-Northwest (ca. 1983). Significant NPS-rustic style characteristics are visible here: stone foundation, exposed timber frame of 8x8s, shake siding, and braked gable roof. Note, sloped access walkways are treacherous this time of year. The overhanging roof provides good protection to entries at each end. (HABS #CA 2148 C-1).

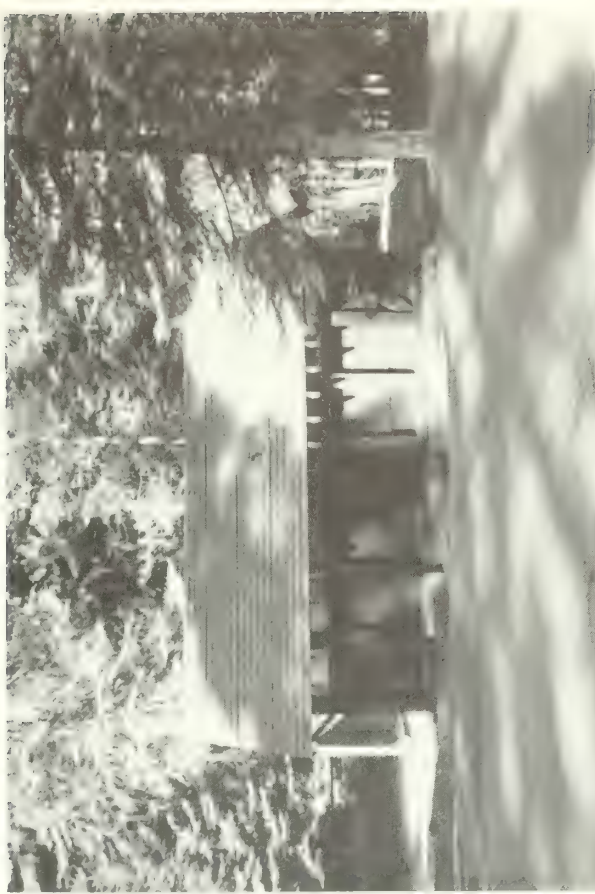
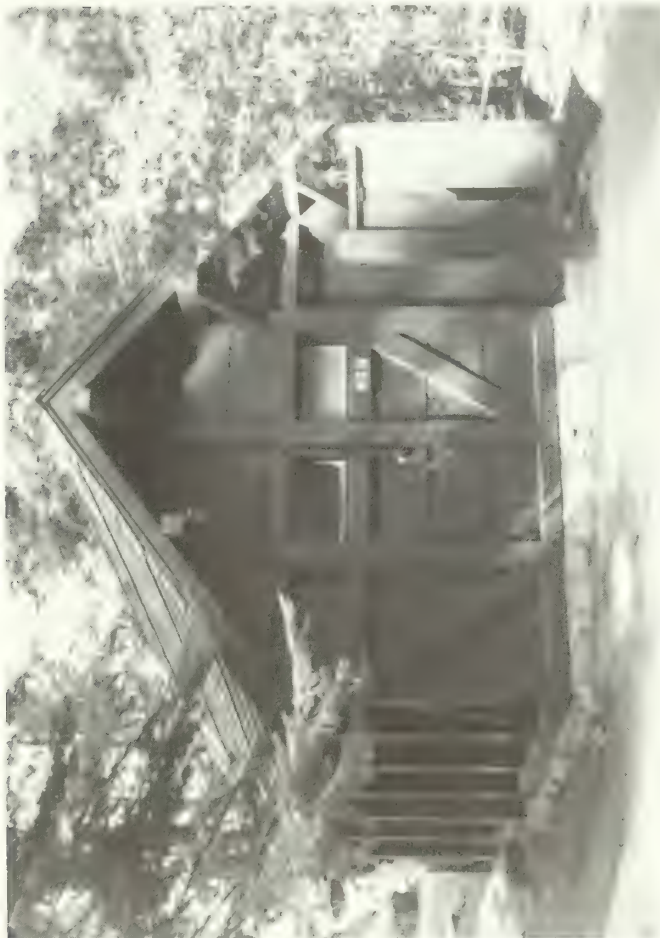
Figure 66. Comfort Station, North and East Facades (5/86). The wood shingled roof with double coursing is significant in these views. Notice, site grade piles up at foot of building from service road. Notice, also, inconsistent glazing pattern in view of men's side.

13) doors are aged and damaged	13) normal use	
14) lack of uniform window glazing (see figures 66, 93, and 94)	14) variety of window glazing patterns exist due to replacements at different times with non-matching glass

members to protect the wood from deterioration (see figure 66). See existing measured drawings (HABS) for documentary data.

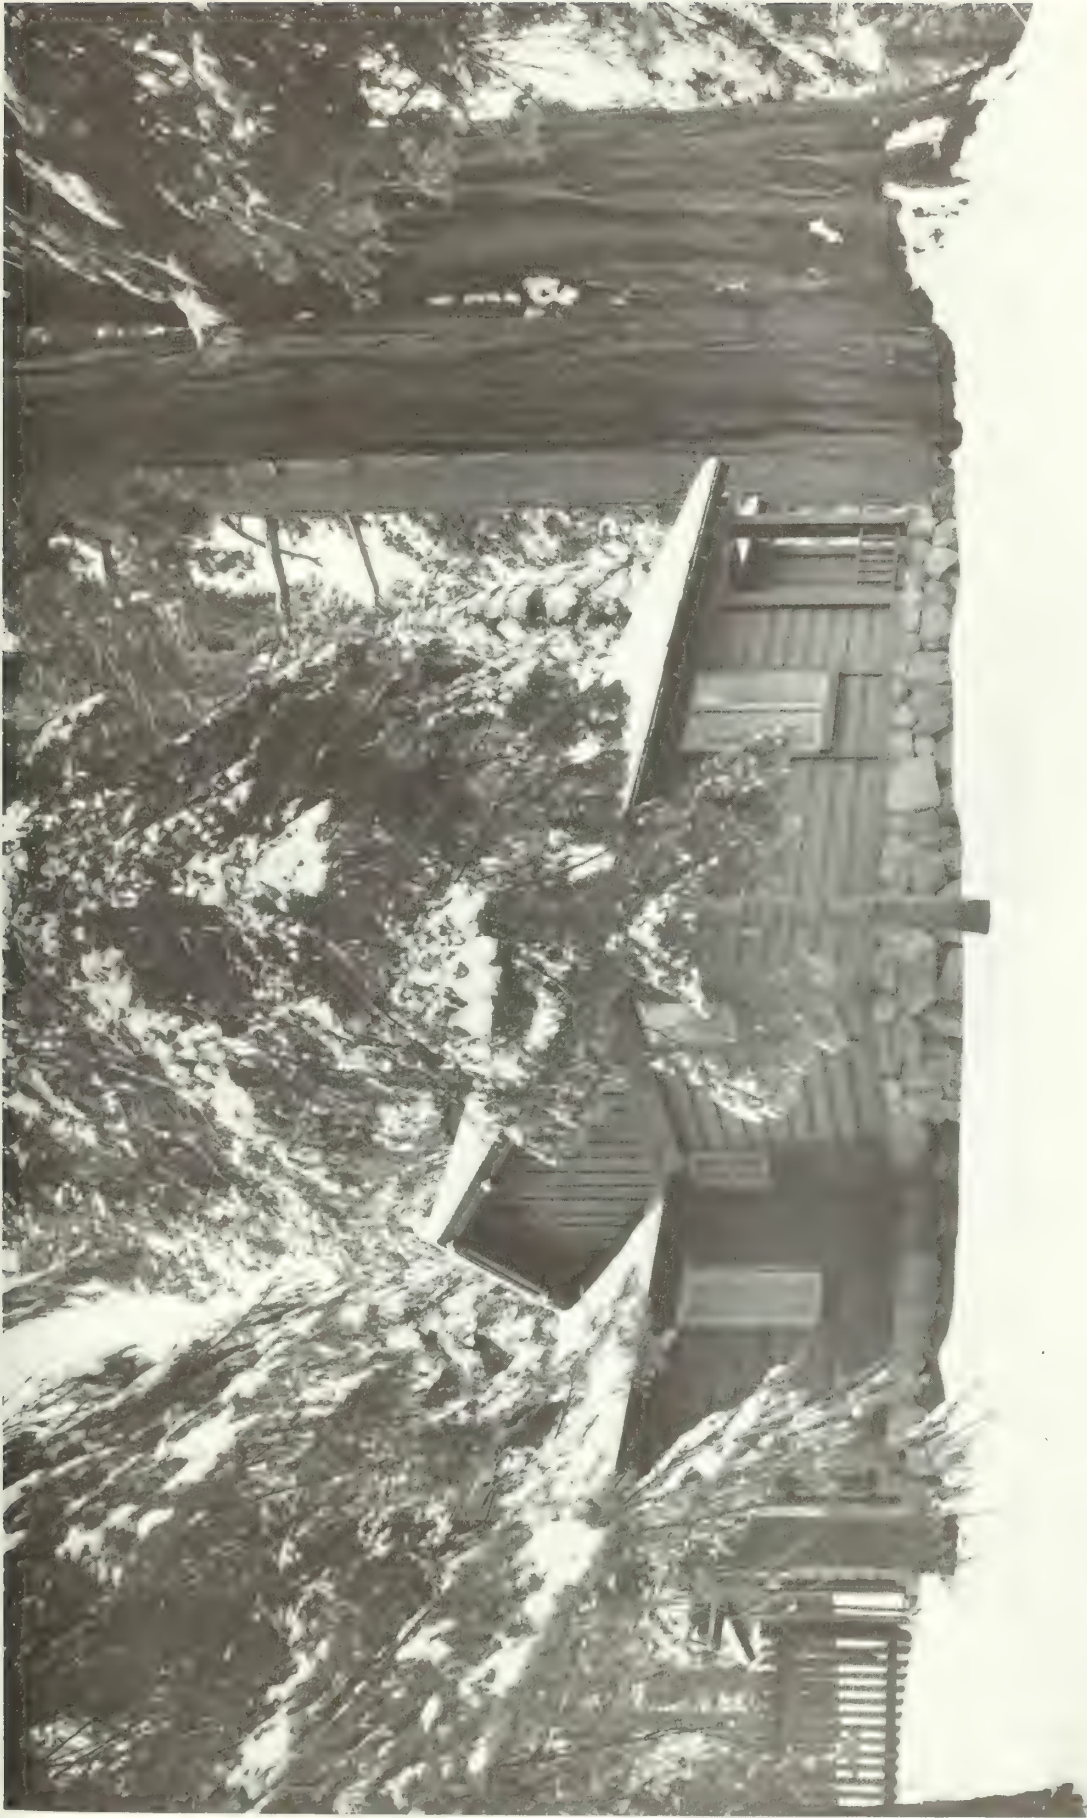
Figure 67. Ranger Residence, View from Northeast (ca. 1983). The stylistic simplicity of the residence is clear in this view within its rhythm of horizontal lap siding and verticle exposed framing and board-and-batten gable end. Of equal importance is the deeply raked stone foundation. (HABS #CA 2148 E-1)

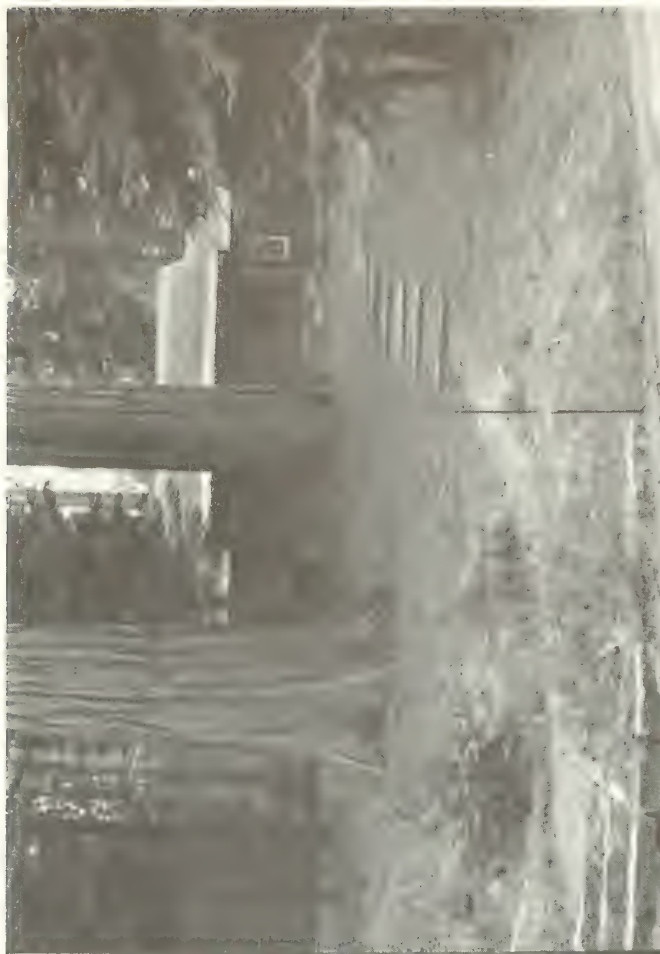
Figure 68 (left). Ranger Residence, View from West (10/86). At left is the front entry to the residence; it is not used much today. The stone chimney is one of the most distinctive exterior features. The snow tunnel and garage are off to the right.

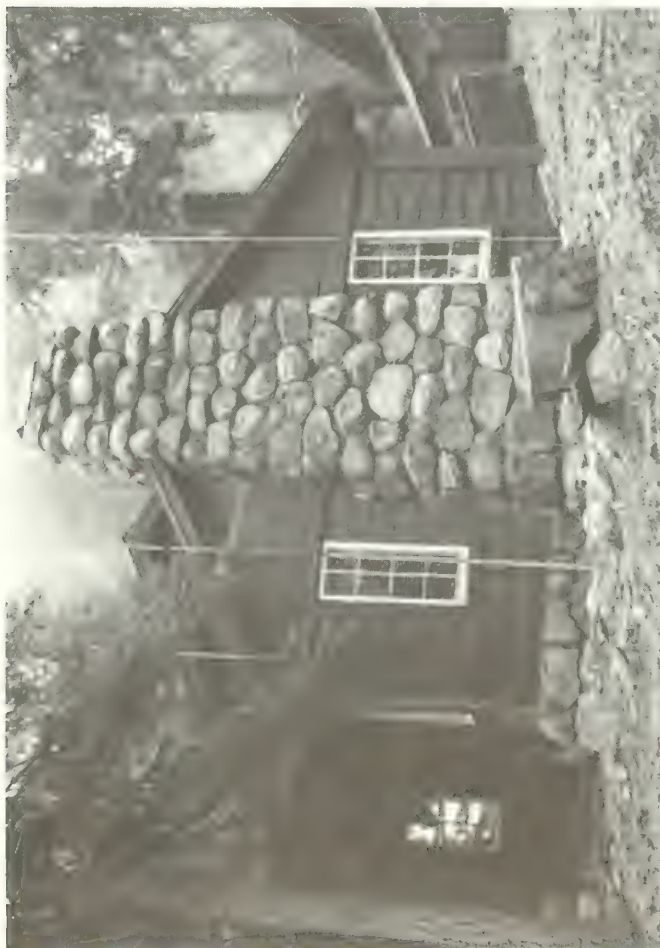
Figure 69 (right). Ranger Residence Site (10/86). Although on a hill overlooking the village (out of view, left) the residence is well blended and hardly noticeable in its natural landscape. The walkway, with stone and timber steps is in need of preservation.

Deficiency	Cause/Notes	Treatment
Site Work and Landscape		
6) negative surface water drainage towards house (see figure 96)	6) from hillside and build-up of natural fill	rebuild stone retaining wall and regrade immediate site to achieve positive surface water drainage; repair or replace gate and fence
7) natural debris build-up along west and south foundation (see figure 96)	7) historic stone retaining wall has collapsed	wooden elements and/or hardware; restore walk by removing soil build-up
8) gate loose at hinges and fence deteriorated (see figure 97)	8) same as #1	
9) walk has deteriorated (see figure 69)	9) same as #1, soil erosion

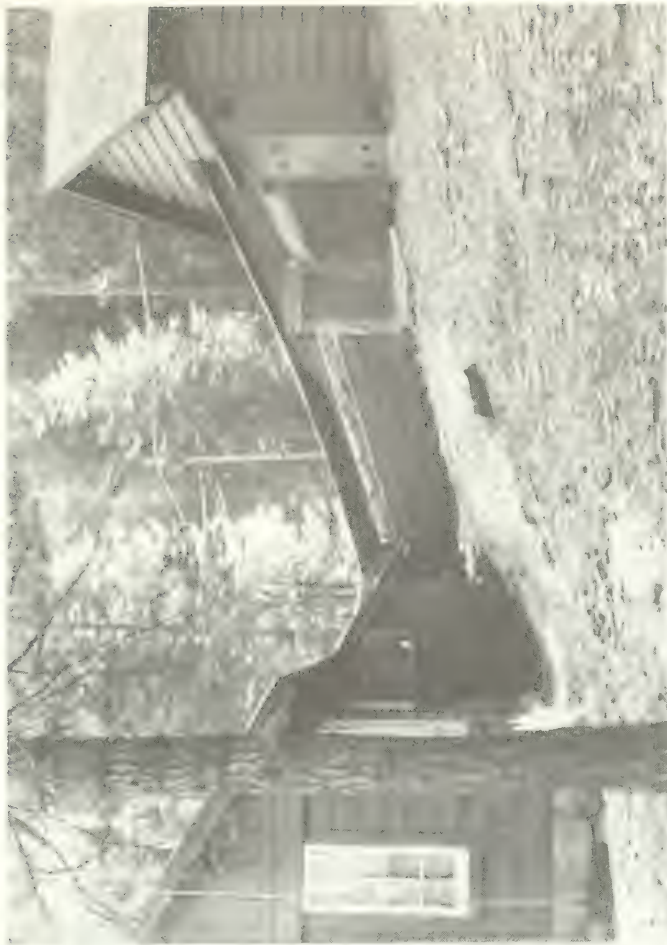
Figure 70 (left). Ranger Residence and Garage (10/86). This view, looking down at both structures, shows their spatial relationship--connected by the snow tunnel--and their stylistic, and material compatibility. The roof extension shed on the garage was added about 1984.

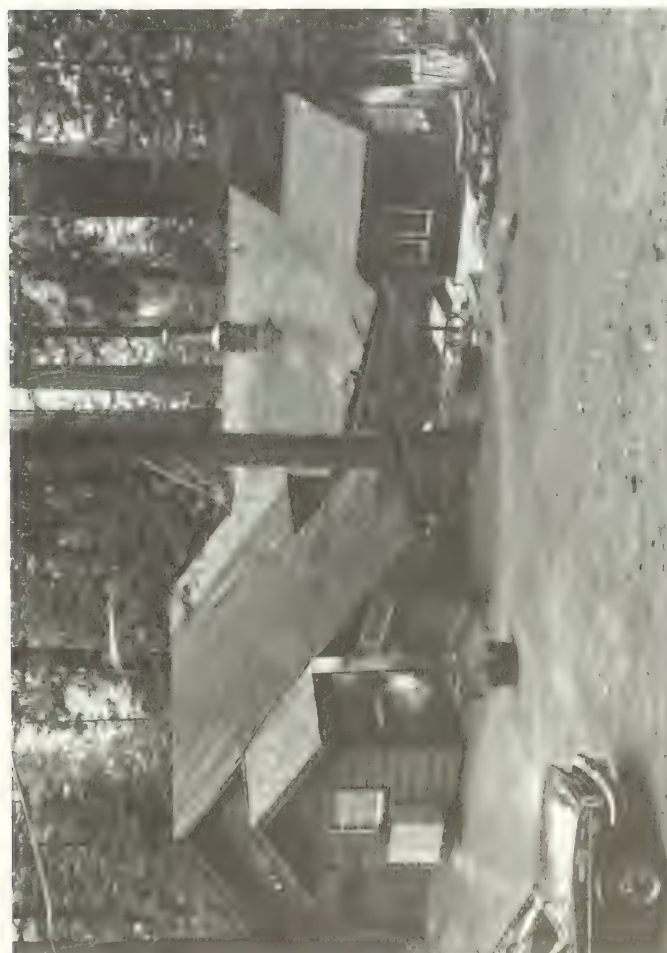
Figure 71 (right). Ranger Residence Snow Tunnel (5/86). This view shows the make-shift snow tunnel connecting the residence (at left) with the garage. The board-and-batten shed roof addition on the rear of the residence was built in 1953. The shed roofed closet attached to the rear of the garage houses storm sash/screen sash for the residence but was originally built in about 1953 to house LP gas tanks.

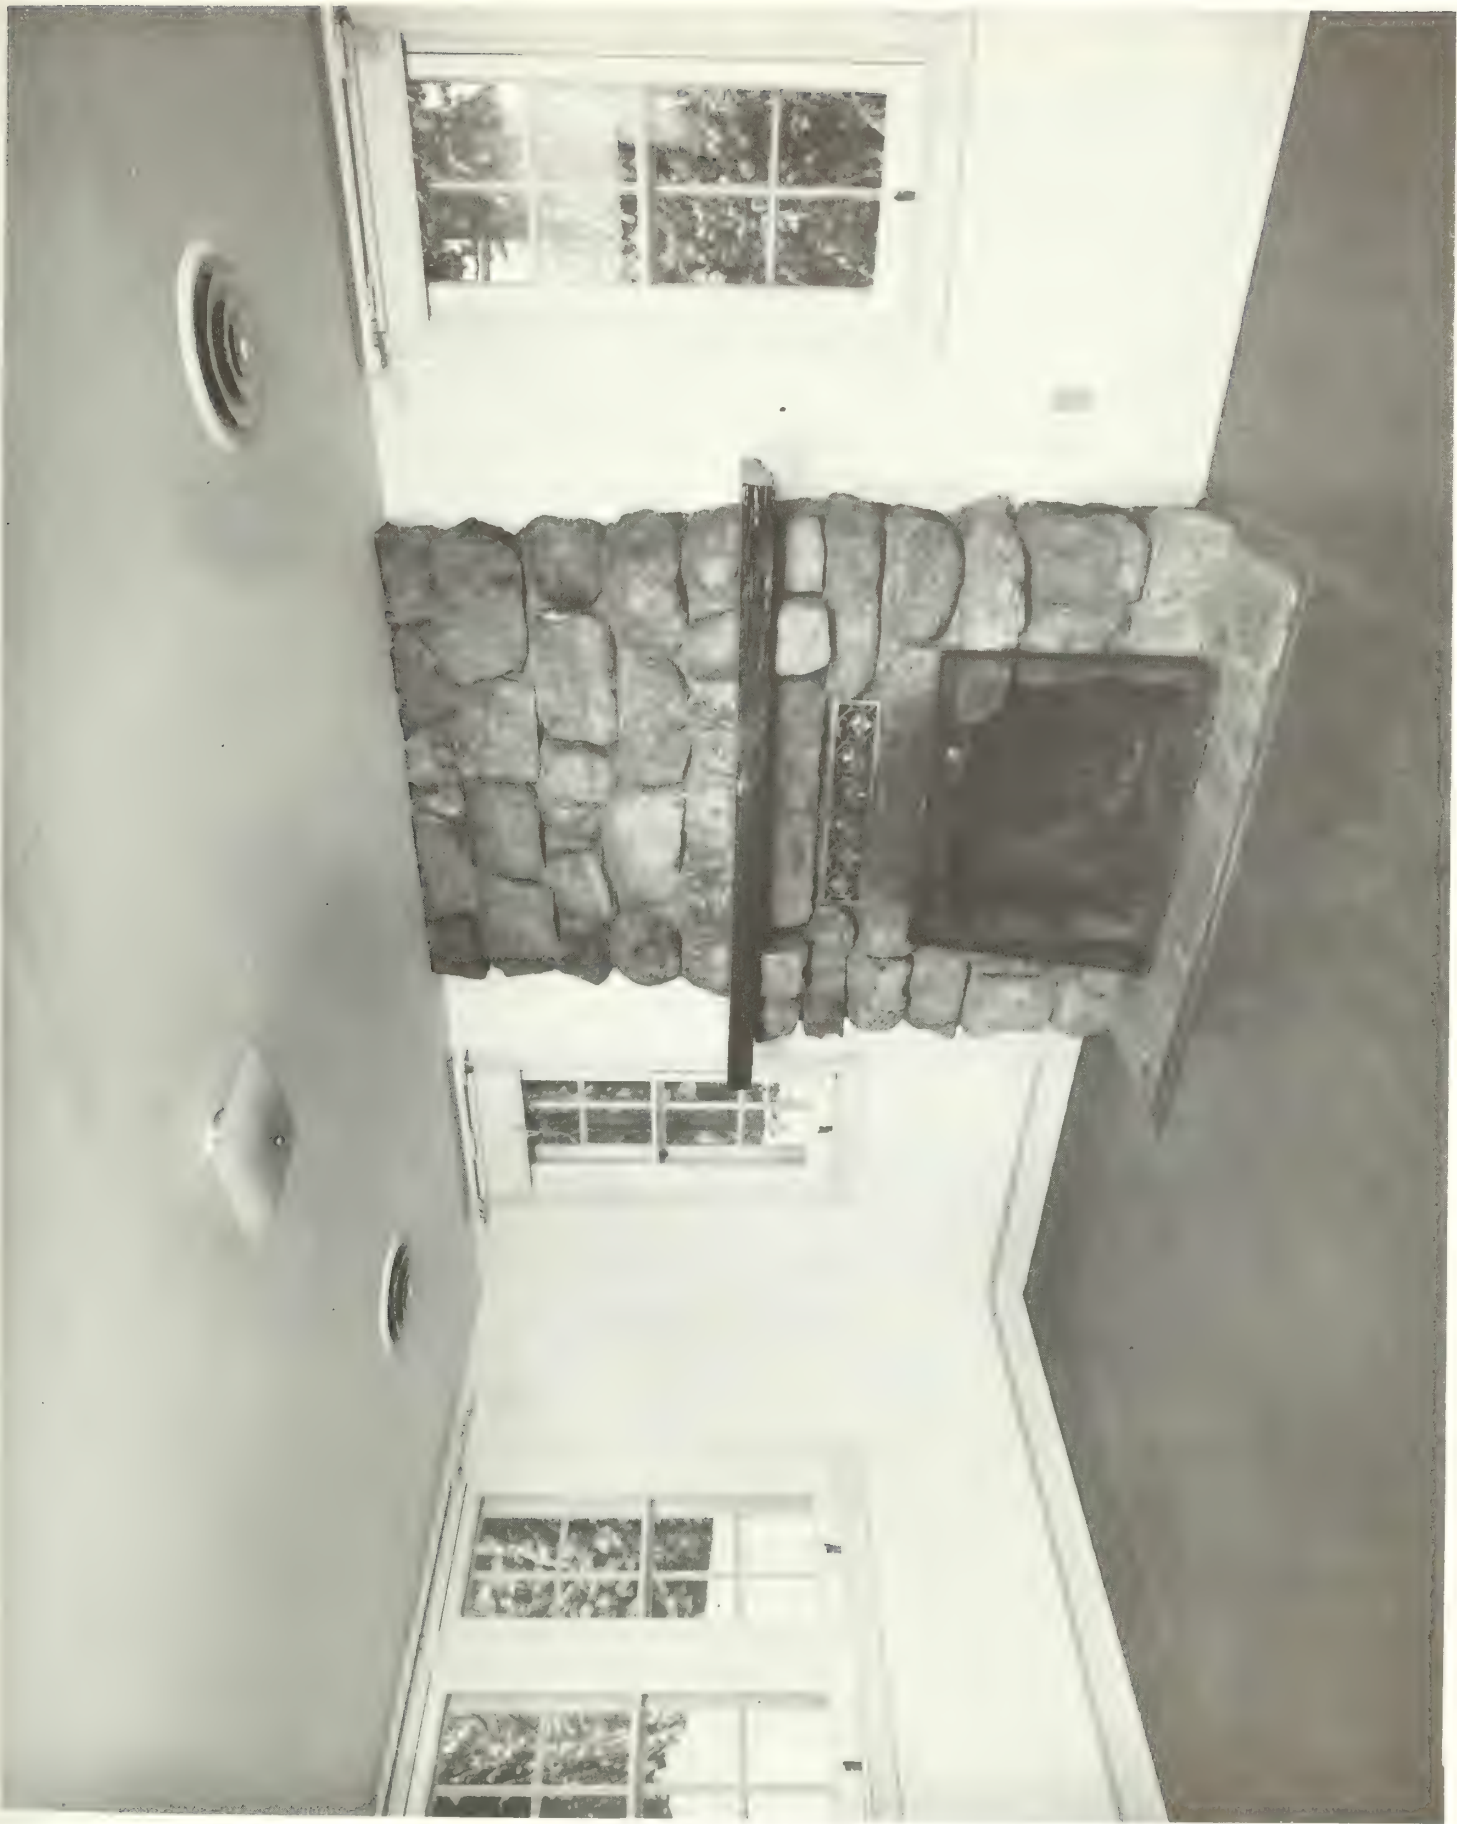
Figure 72. Ranger Residence Fireplace (ca. 1983). This interior view--prior to 1983 rehabilitation--shows the distinctive fireplace and dark stained pine flooring. Electrical work included grounded wiring in 1983. Except for the installation of a fire detection/warning system and GFCIs in the bathroom and kitchen, no interior work is recommended for the ranger residence (HABS #CA 2148 E-7).

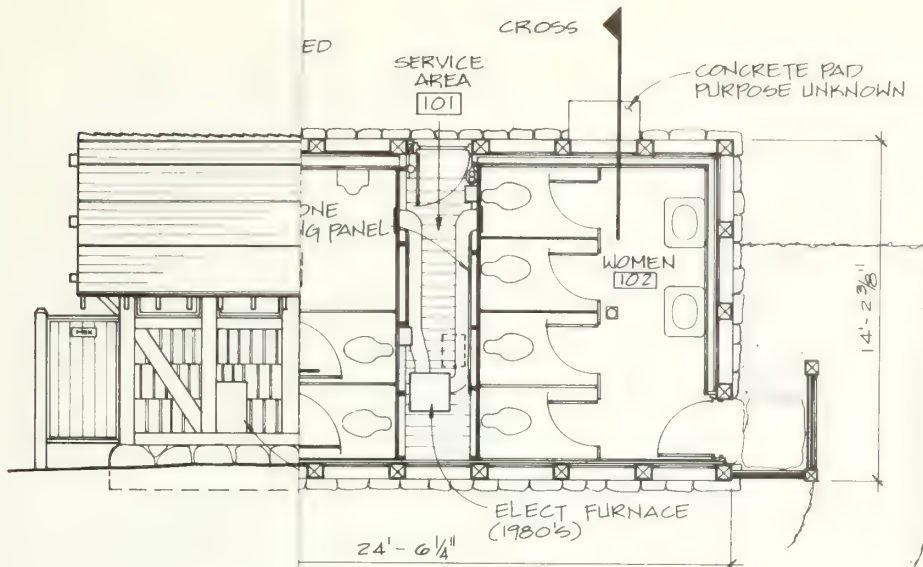
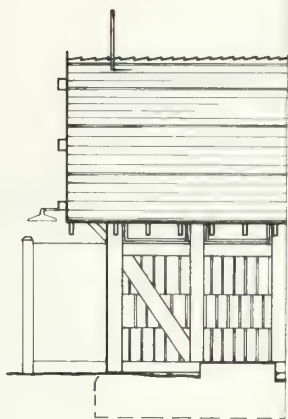
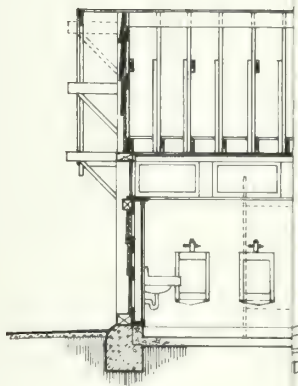
LD SM ZIER REVIEW	SUB SHEET NO.	TITLE OF SHEET	DRAWING NO.
		COMFORT STATION	102
		PLAN, ELEVATIONS, SECTIONS	25,000A
			PKG NO.
			SHEET
			8
			OF 12

SOME ORIGINAL TRANSLUCENT RIPPLE GLASS REMAINS
REPLACEMENT PANES DO NOT MATCH

EXISTING WOOD SHINGLE ROOF IS PROBABLY SECOND
GENERATION BUT SIMILAR TO ORIGINAL GREEN
PAINT IS MOSTLY GONE

BUILDING IS USED FOR ELECTRICAL & TELEPHONE
SWITCHING STATION FOR OTHER STRUCTURES

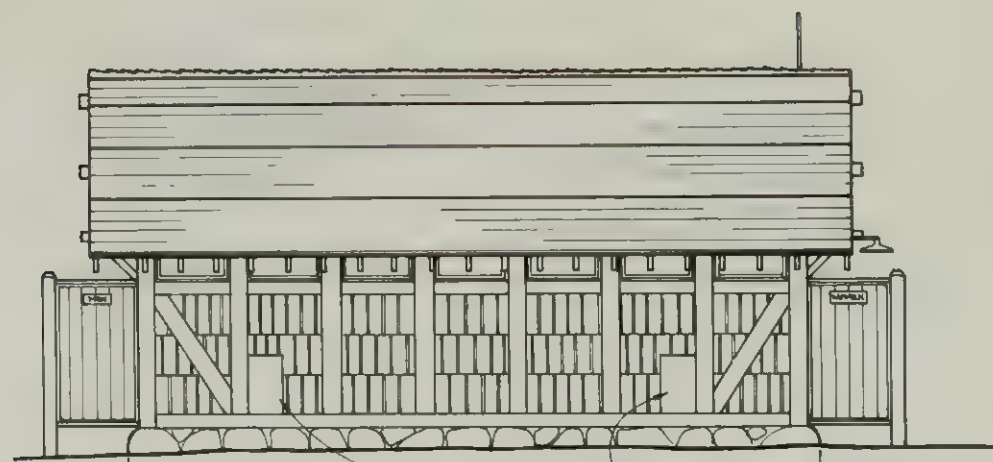
WEST

PLYWOOD ELECT PANEL
BOXES (NOT ORIGINAL)

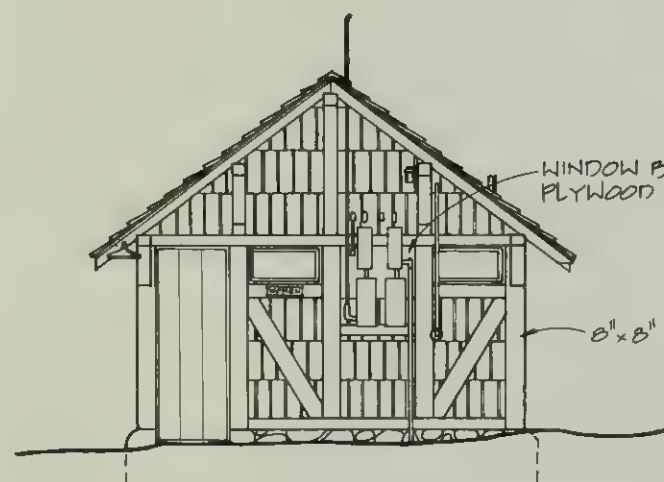
SOUTH

WINDOW BEHIND
PLYWOOD PANEL

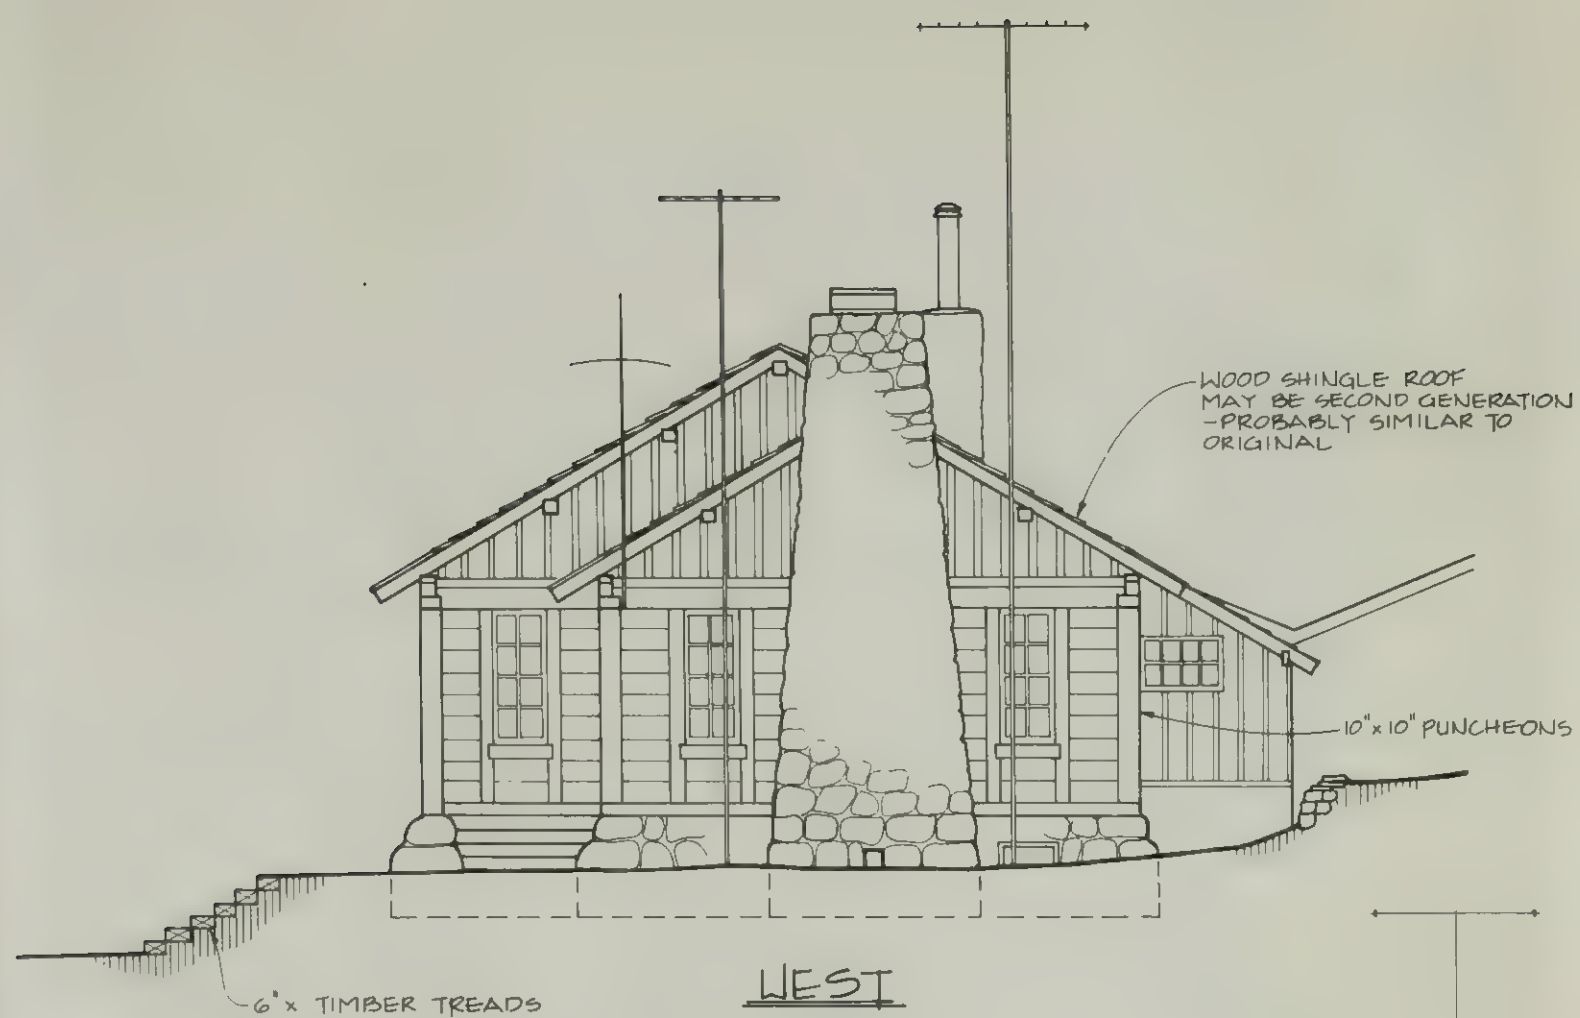
3' EAVE FLASHING
MAY NOT BE ORIGINAL

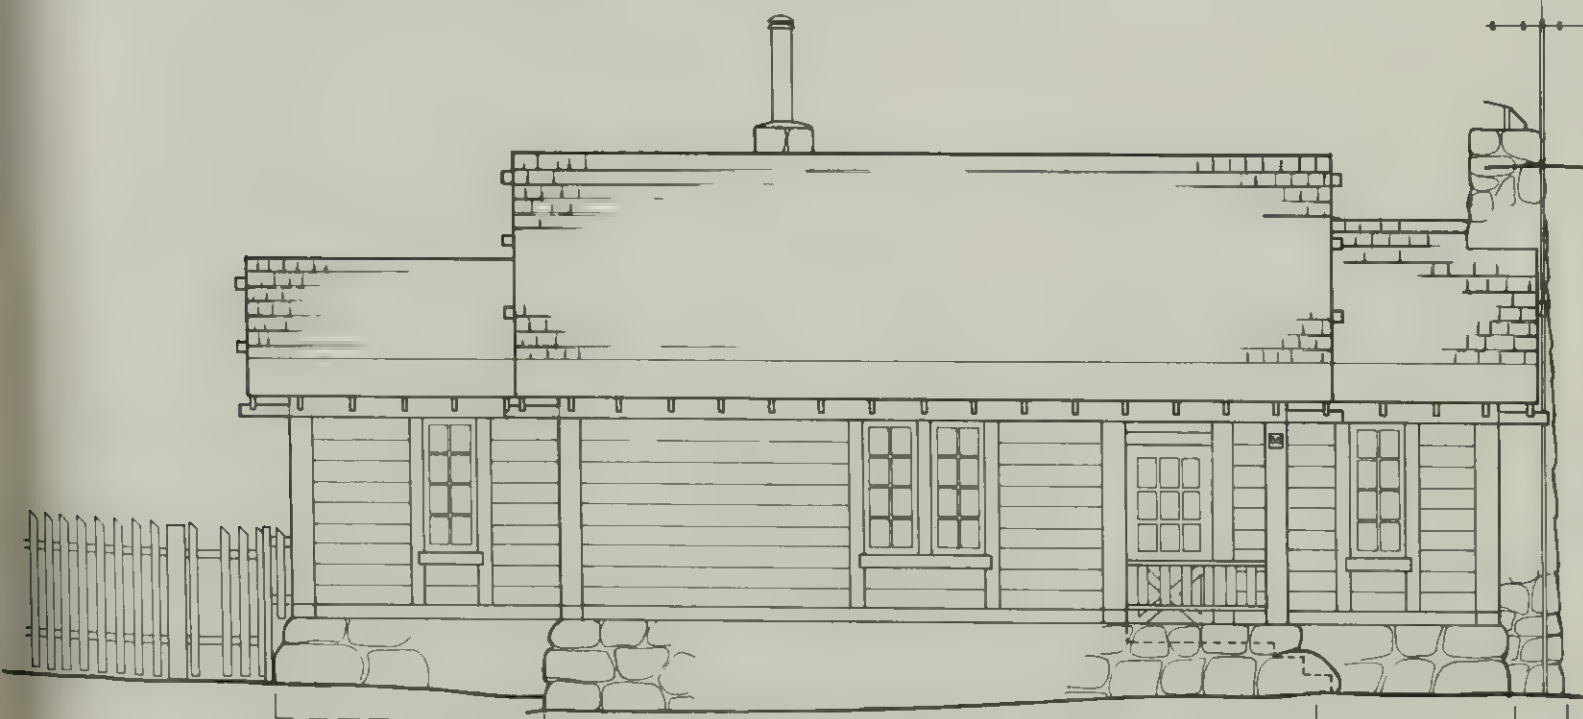
NORTH

ENTRY PORCH NOT BUILT
ACCORDING TO ORIGINAL
CONSTRUCTION DRAWINGS

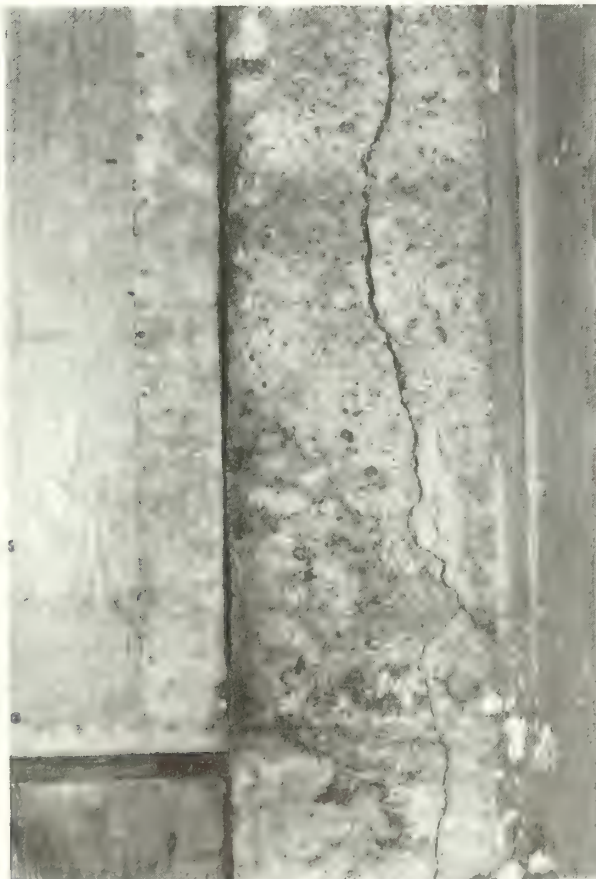
Figure 75 (left). Market - Rot at Southeast Corner (5/86). The site grade at this location produces negative drainage (run-off flows towards the wooden sill of the building). The result is near total loss of the 8x8 sill plate due to resulting rot, partial loss of the corner puncheon, and loss of shiplap siding (replaced with the plywood patch). These materials should be replaced and grading performed to facilitate positive drainage.

5) rotted and damaged wall sill beam at southeast corner of building 1 (see figure 75)	5) negative surface water drainage and natural build-up of grade next to building

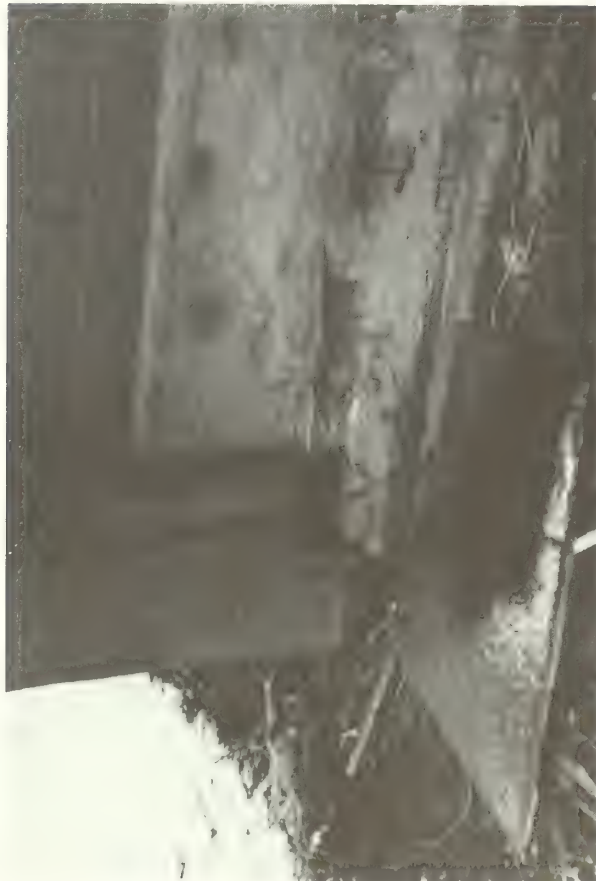
Figure 77 (left). Market - Shed Addition Roof (5/86). Uplifting of the aluminum panel roofing (1975) is indicative of its loosening and deterioration. Note also, some damaged and deteriorated rafter tails. The metal roof should be removed and roll roofing replaced. Rot should be cut out of rafter tails and voids filled with dutchmen patches, carpenters wood filler and/or epoxy.

Deficiency	Cause/Notes	Treatment
<u>Roof and Chimney</u>		
8) existing metal roof is failing and is an intrusion on historic appearance (see figure 77)	8) existing 1975 metal roof was temporary and has reached end of life expectancy	Remove metal roof and replace painted wood shake roof beneath, duplicating its historic appearance; install new felt roofing on 1938

9) some rafter tails deteriorated and damaged ⁴ (see figure 77)	9) exposure to elements	shed addition and dormer; reflash hips, valleys and chimneys; repair or replace deteriorated and damaged rafter tails; close holes at soffitt
